## ELMLEY CASTLE PARK

### TREE CONDITION ASSESSMENT

Prepared for: Elmley Castle, Bricklehampton and Netherton Parish Council

Project reference: E.3299

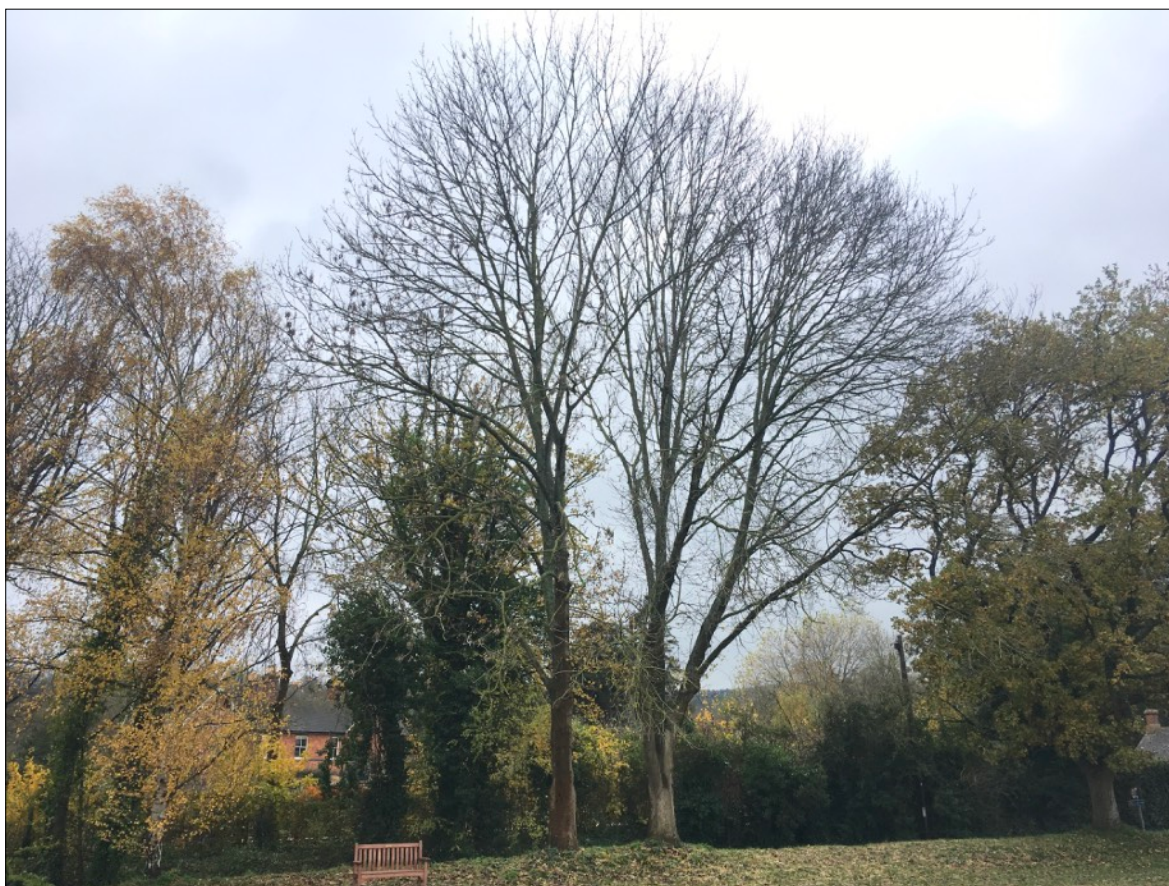
3.7. The ash appears to be in decline as evidenced by the sparse bud density and deadwood in the crown. It also has a poorly formed union between the second-order stems. The adjacent tree, also an ash, forms a cohesive canopy with the tree in decline so removal of the one tree would result in an imbalanced form for the remaining tree, as well as leaving it more exposed to new wind forces due to the removal of the mutual shelter. In my opinion crown reduction pruning of the remaining tree would not mitigate this impact, so I have recommended that both ash trees (30887 and 30888) are felled. Whilst this may seem like a high impact on the visual amenity of the playing field, it is foreseeable that both ash trees could succumb to 'ash dieback' which would shorten their lives anyway, so removal of these trees and replacement with a different species makes sense for the long-term in any case.

*Photo 1: ash trees 30887 (left) & 30888 (right) recommended for removal.*

| Ref | Species | Height | Diameter | Age class | Form | Target Status | Condition | Notes / Defect type | Hazard magnitude<br>(Hazard trees only) | Likelihood of failure<br>(Hazard trees only) | Recommended action | Priority |
|---|---|---|---|---|---|---|---|---|---|---|---|---|
| 30888 | Ash | L | M | M | Asym | 2 | G | There are no significant defects observed. However, the removal of the adjacent ash which forms a cohesive canopy with this tree may lead to an increased likelihood of limb failures due to the removal of the mutual shelter. Reduction pruning is not considered to be a desirable long term management approach, so removal and replacement is recommended. | | | Fell | 2 |
